# Applying the SAFEGROUNDS Key Principles in the real world: A case study at Hunterston A - the VLLW Disposal Area

Based on presentation to SAFEGROUNDS/SD:SPUR Conference on “Managing Contaminated Land and Decommissioning Wastes on Nuclear and Defence Sites”, Manchester, 3-4 June 2009  
**Amended version to support Version 2 of SAFEGROUNDS Case Study, November 2011 (\*denotes updated/new slides)**

# Hunterston A Site, North Ayrshire

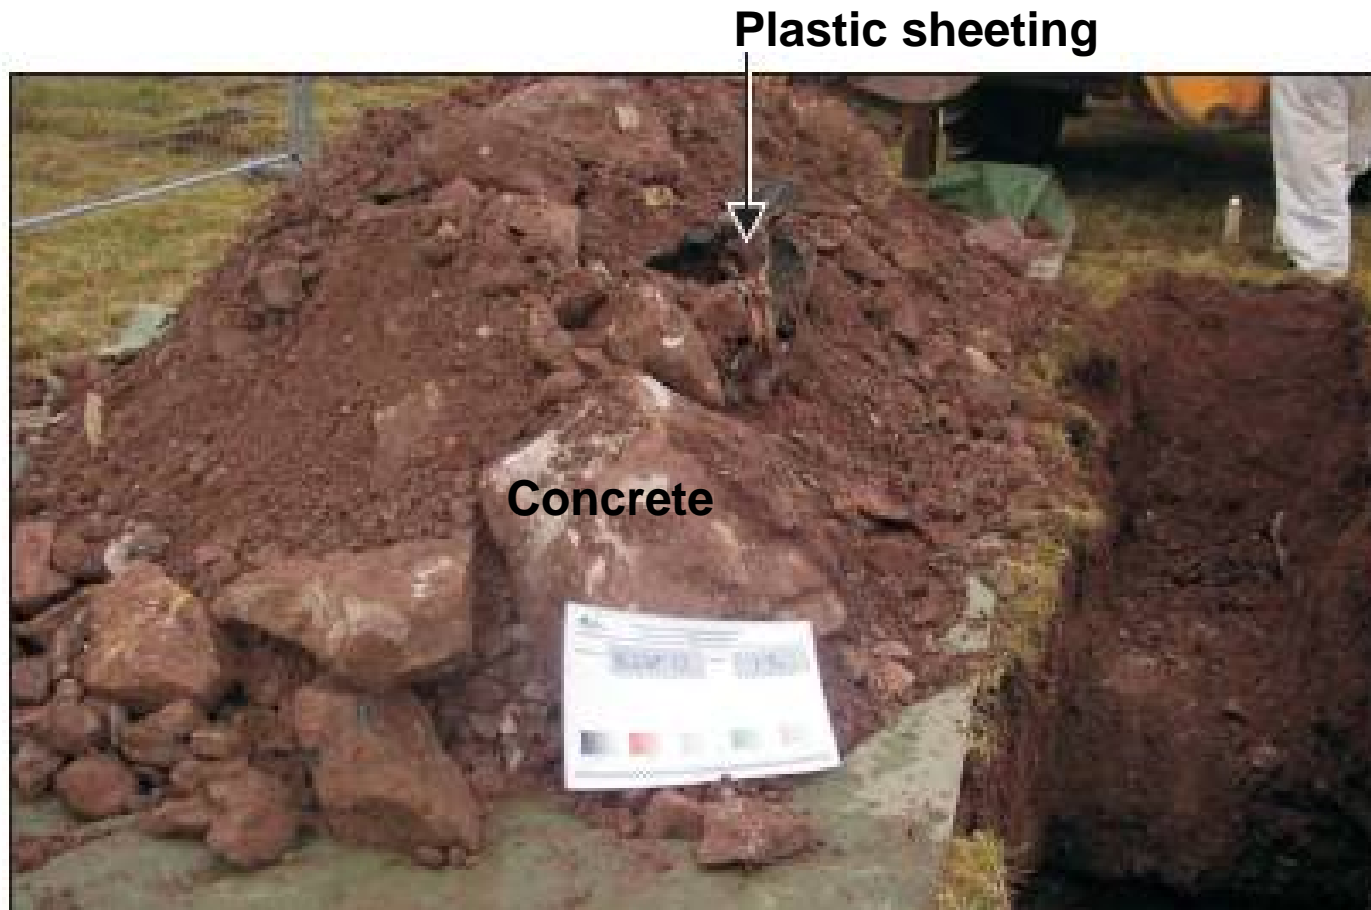
# Typical waste (2005 trial pit investigation)

- Specified coordinates for locations of burial pits
- Solid waste of specified types (soil, vegetation, concrete, rubble) – not containerised
- Limits on radioactivity levels
  - 3.7 Bq/g for ~90% by volume (equivalent to modern category of ‘High Volume Very Low Level Waste’)
  - <19 Bq/g for ~10% by volume
- Limits on volumes per pit (total 6400 m<sup>3</sup>)
- Implied limit on total radioactivity (56 GBq)
- Burial below 1.5 m of uncontaminated soils

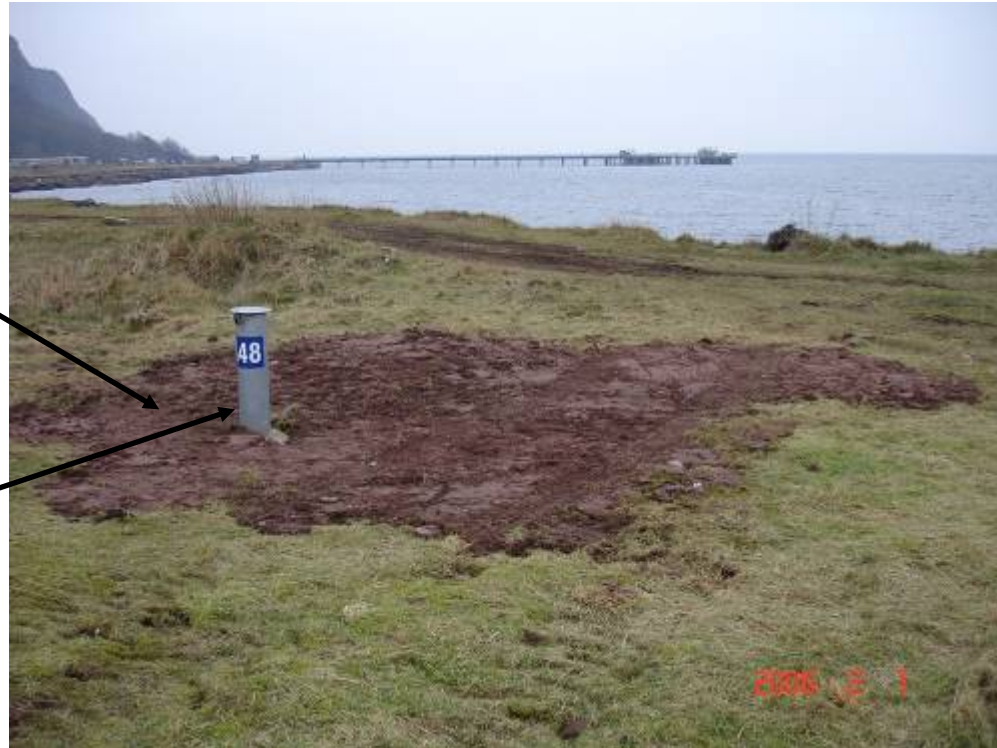
# 'Immediate Action' (KP4)

- Interim remediation of patch of surface contamination found by 2005 survey (Jan 2006)

Clean soil placed over 'marker' layer of geofabric

Borehole headworks (not related to remediation)

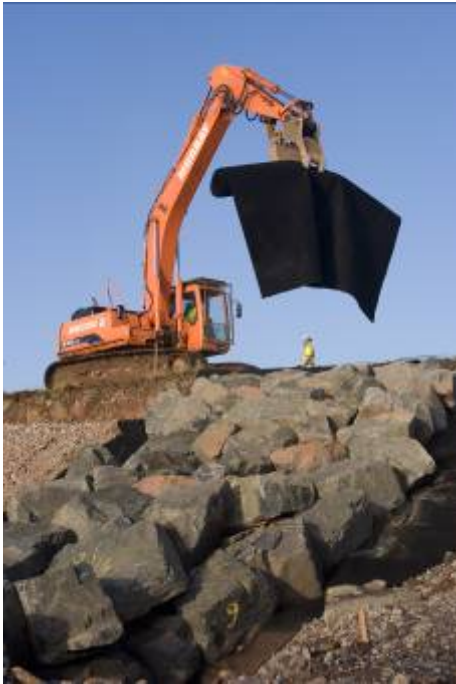
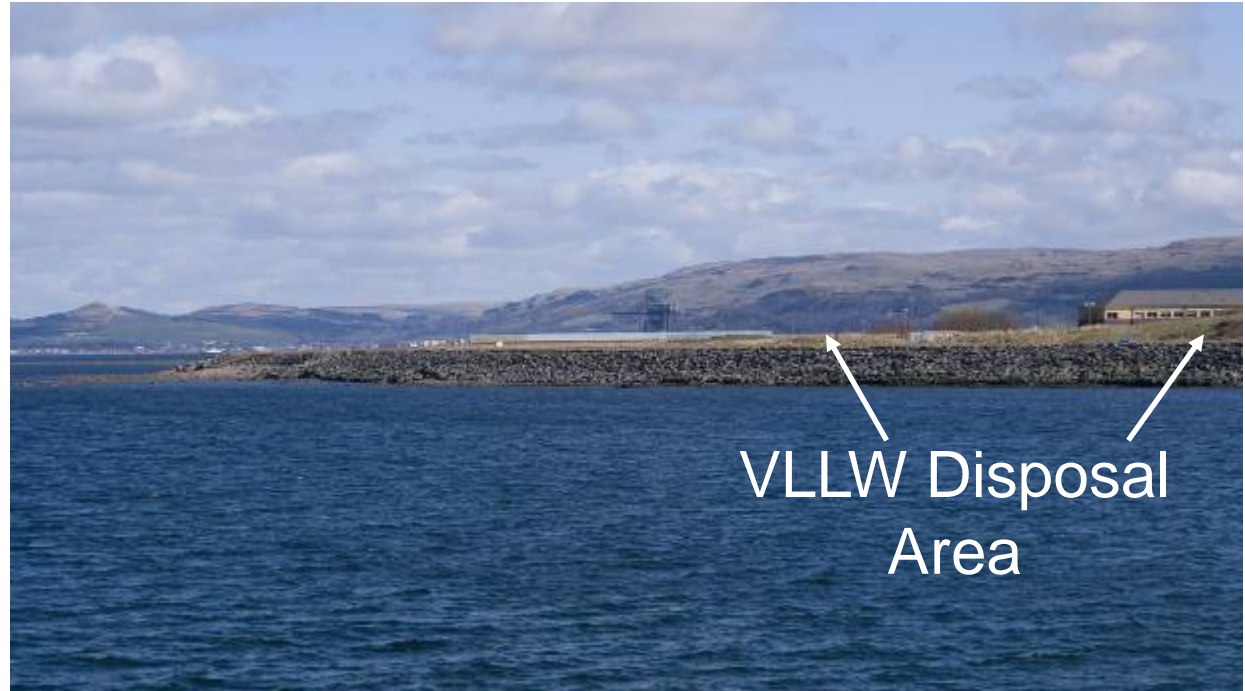
## 'Immediate Action' (KP4)

- Coastal defences damaged by severe storm, night of Hogmanay 2006
- Reinforcement work implemented 2007-08

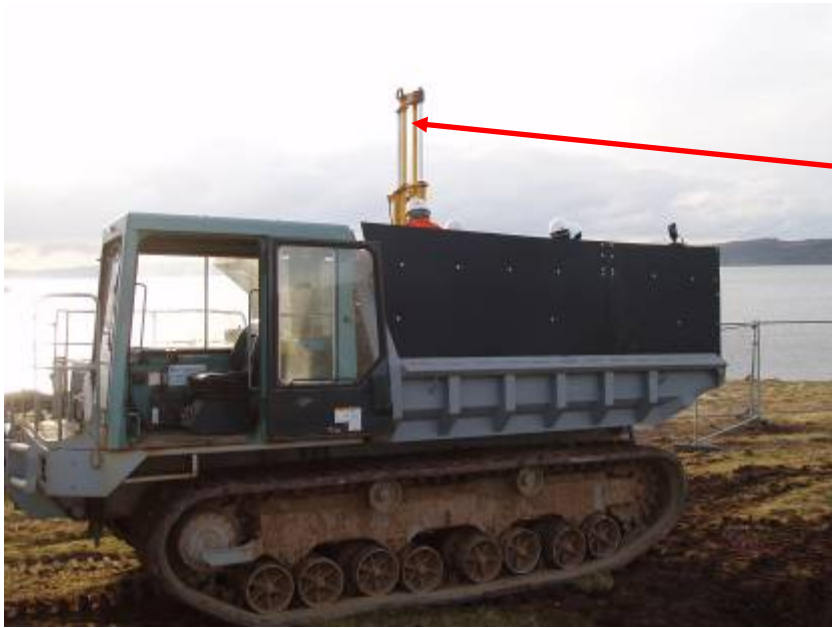
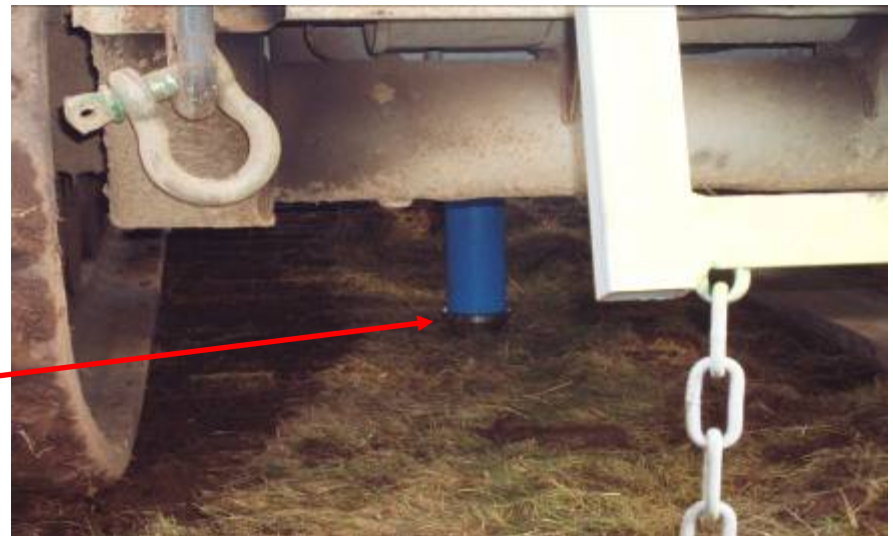
# Direct push installation of temporary boreholes for down-hole gamma spectrometry (1)

Track-mounted cone penetrometer testing rig

Metal rods and sacrificial tip used to drag plastic pipe into the ground

- Aerial photo-interpretation – Pit 1 capping mound within marker posts (but no features seen for other pits)
- Geophysics – inconclusive
- Trial pitting across inferred edges of pits – inconclusive
- Overall conclusion: radioactive contamination (caesium-137) probably the best guide to the location of the wastes
- Need for a large number of sub-surface contamination data points, but not ‘at any cost’
- Opportunity for innovative intrusive method, developed jointly with VT Nuclear Services and Golder Associates

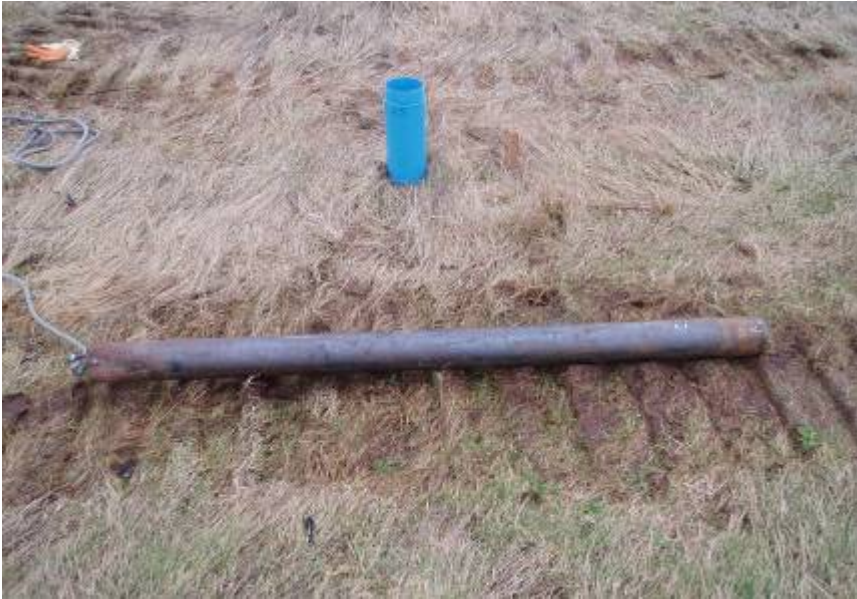
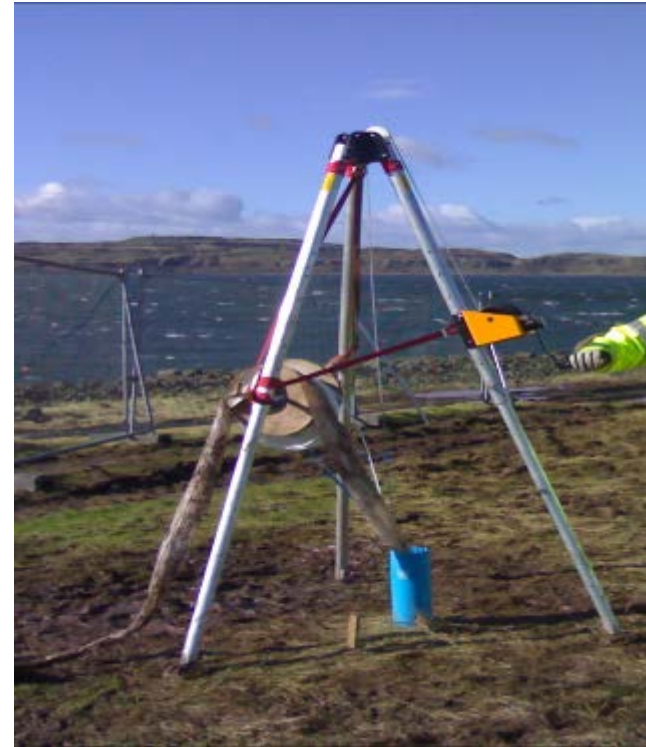
## Direct push installation of temporary boreholes for down-hole gamma spectrometry (2)

Down-hole high-resolution gamma probe ready for deployment

Probe deployed in temporary borehole

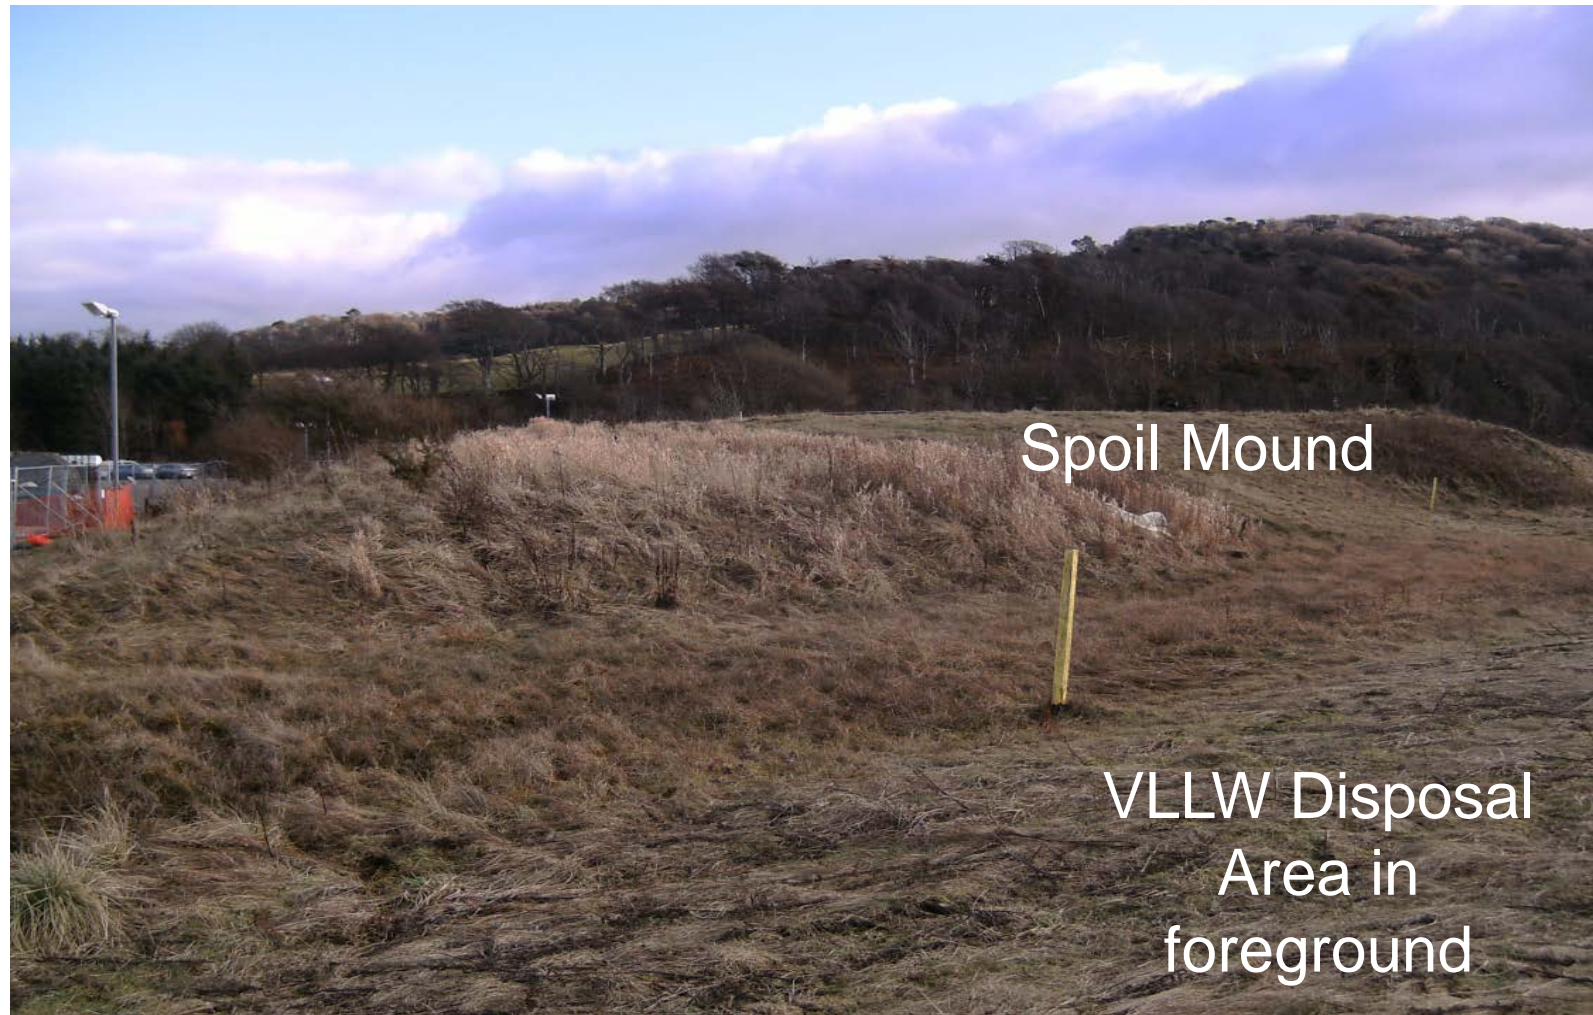
## \*Spoil mound to be used for restoration soils

- Further characterisation work to confirm suitability of existing soil mound for use as part of restoration cap
- Ecological survey:
  - To identify any protected or locally rare species or important habitats that might be affected by restoration works (locally rare parsley water dropwort found);
  - To determine whether the restoration cap should include measures to minimise potential for burrowing into the waste (not required)

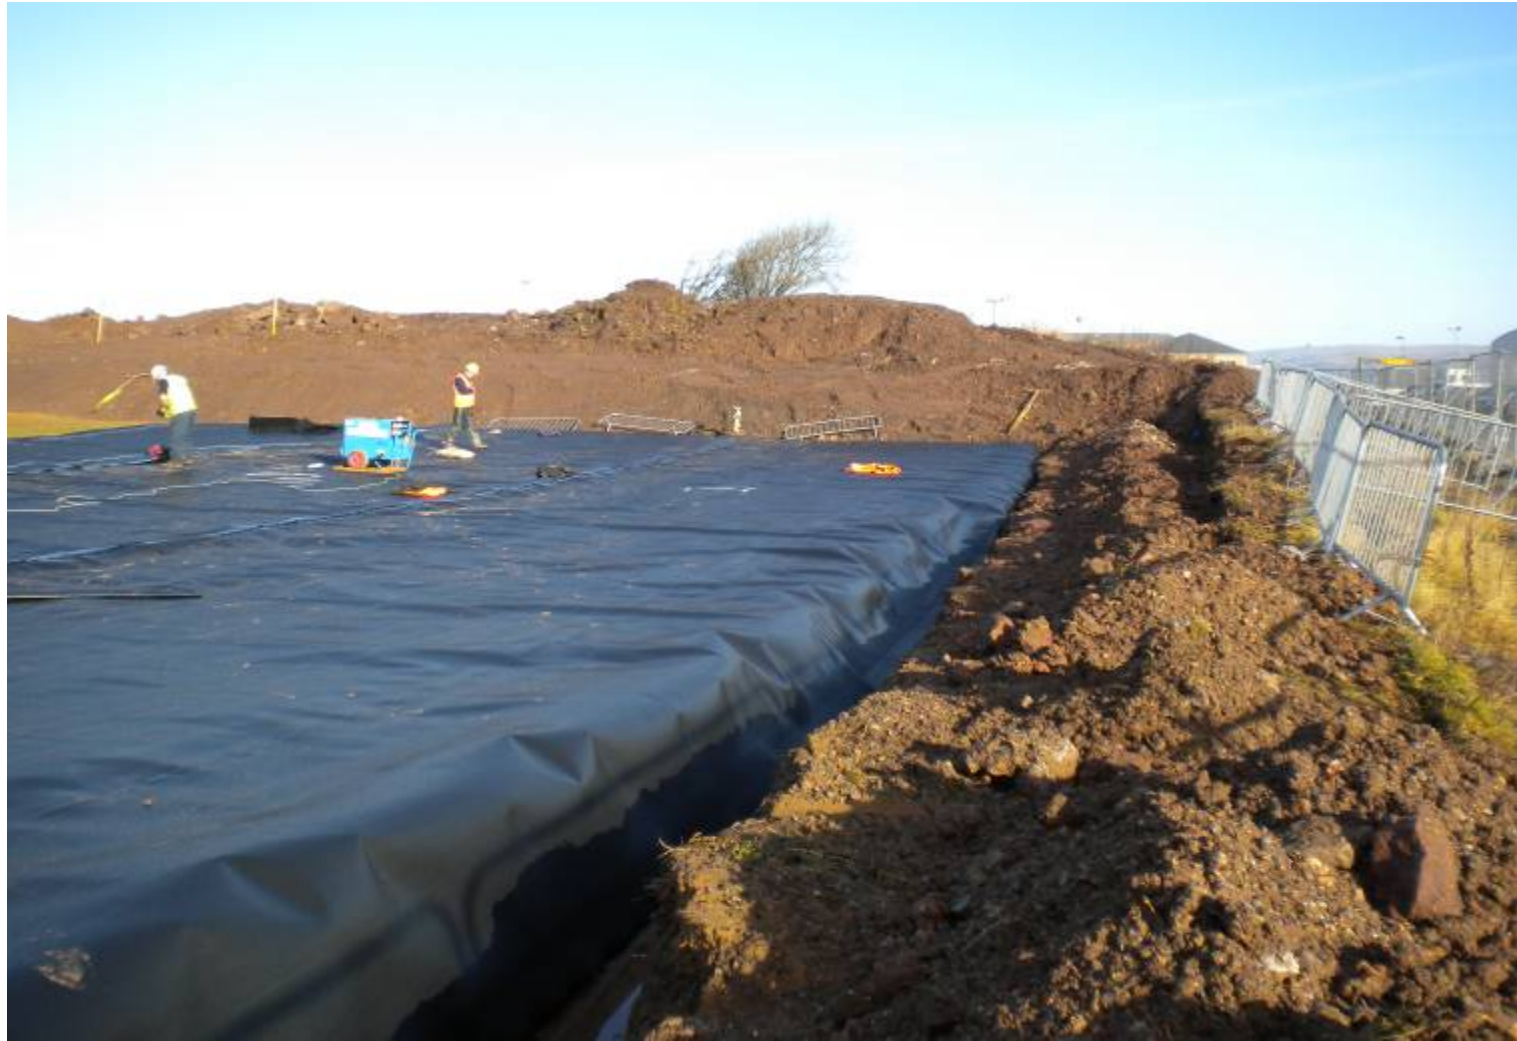
## \*Works in progress – HDPE membrane

- Technical options considered:
  1. No engineered barrier under restoration soils (just a separator geotextile marker layer)
  2. High-density polyethylene (HDPE) geomembrane 'liner' (+ protective geotextile)
  3. As Option 1, with addition of 'rabbit mesh' ~0.2 m below ground level
- Option 2 adopted as 'standard practice' for a landfill cap
- No need for 'rabbit mesh'
