# Sellafield Ltd

## Characterisation to Justify the Appropriate Management of Solid Wastes in the Nuclear Industry

**Case Study: Characterisation in support of the refurbishment of the Sellafield Sea Line Pipe Bridge**

Date: 25th May 2010

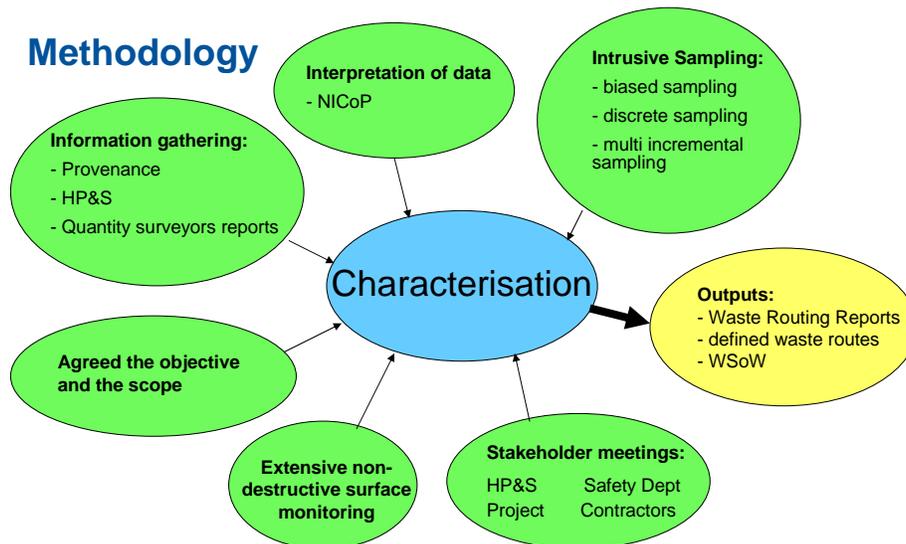
## Methodology

- **Agreed the objectives and scope**
- **Information gathering**
  - building/area history conducted. Provided historic information regarding events, spillages etc
  - historic HP&S surveys
  - quantity surveyors report
- **Non destructive surface monitoring**
  - using hand held instruments.
  - provided detailed information regarding the surface contamination of the area.

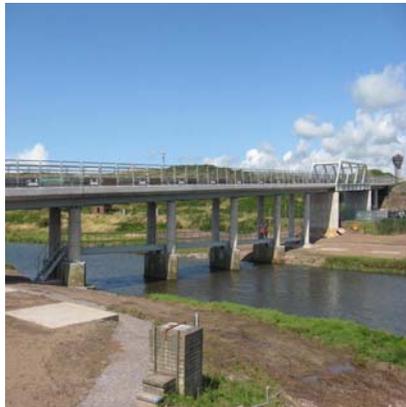
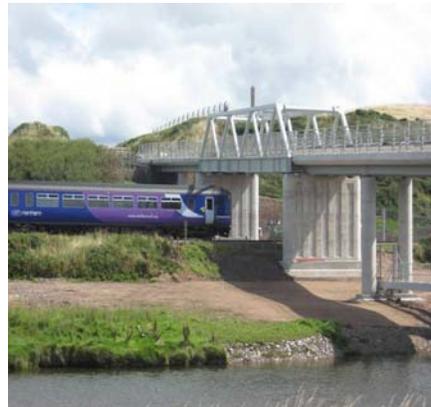
## Refurbished Pipe Bridge

- Project established following a warning of intent by the Environment Agency to issue an Enforcement Notice for the 'failure to adequately maintain an operational effluent pipe line'.
- Controlled area - potential for radioactive contamination.
- The main aspects of the refurbishment included:
  - replacement of concrete piers
  - replacement of the truss
  - replacement of the concrete shield
  - reduction in the width of the deck
  - installation of new steel handrails
